# Piping Failure of a Metro Tunnel Construction

Lee, Wei Feng; Ishihara, Kenji

**ABSTRACT:** In this paper, the forensic investigation of a subway tunnel construction failure occurred in Kaohsiung, Taiwan is presented. The studied construction failure occurred during a cross-pass tunnel excavation of a shield tunnel construction work of the Kaohsiung Mass Rapid Transit system, and had resulted in severed tunnel collapse and extensive ground failure that even reached to ground surface 30m above the tunnel depth. In order to investigate such a serious construction failure, particular soil testing programs and geophysical testing methods were carried out to access the possible failure scenario of the investigated case. Information presented in this paper is hoped to be helpful to improve engineers' knowledge for preventing similar construction risks.

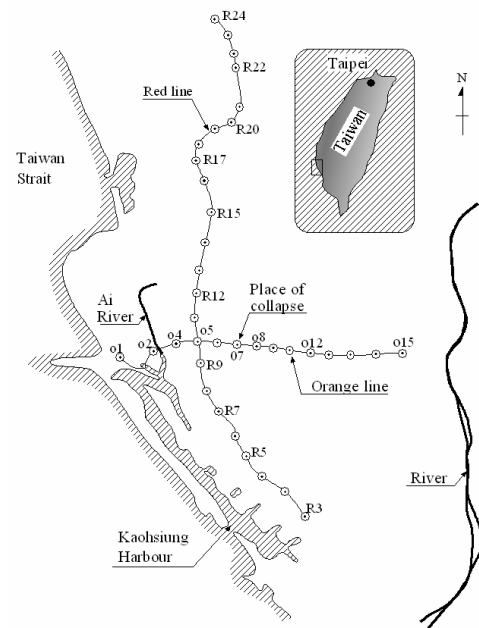
Figure 1. The location of the collapse

The location of the collapse is shown in Figure 1 and the feature of the cave-in on the ground surface is displayed in Figure 2. A bird-eye view over the cave-in is displayed in Figure 3. The plan and side view of the tunnel are shown in Figure 4. It is to be noted that there was an underground roadway called Chung Cheng underpath just above the subway tunnel. The dual tunnels were constructed by the tunnel boring machine (TBM) which can advance by rotating a large steel disk equipped with cutting blade, while the cutting face is balanced by the mud pressure.

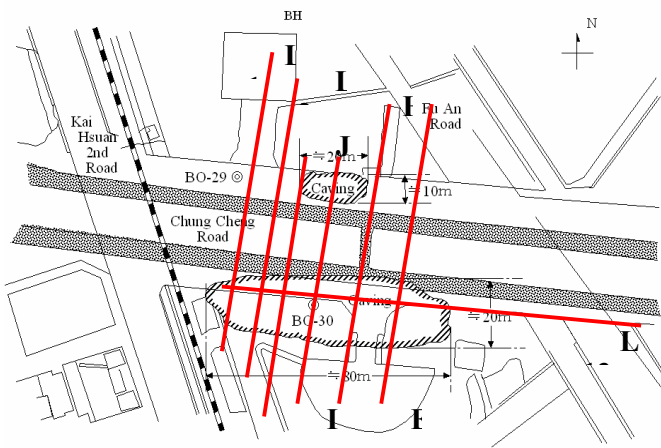
Figure 11. Layout of the RIP test.

In this study, surface 2D RIP testing was conducted to probe ground condition, and to check the effectiveness of remediation grouting right after the accident. Figure 11 shows the layout of the 2D RIP testing. As depicted in the figure, six survey lines in north-south direction and one in east-west direction were installed in an attempt to cover the damaged area; and hopefully to identify different soil conditions and underground structures. As described in previous paragraphs, the corridor was surrounded by grout material which was installed to stabilize the ground prior to excavation. Large numbers of sand bags and backfill material were dumped into the surface sinkholes to stabilize the disturbed ground after the event. Ground conditions were fairly complicated when the 2D RIP survey was conducted.

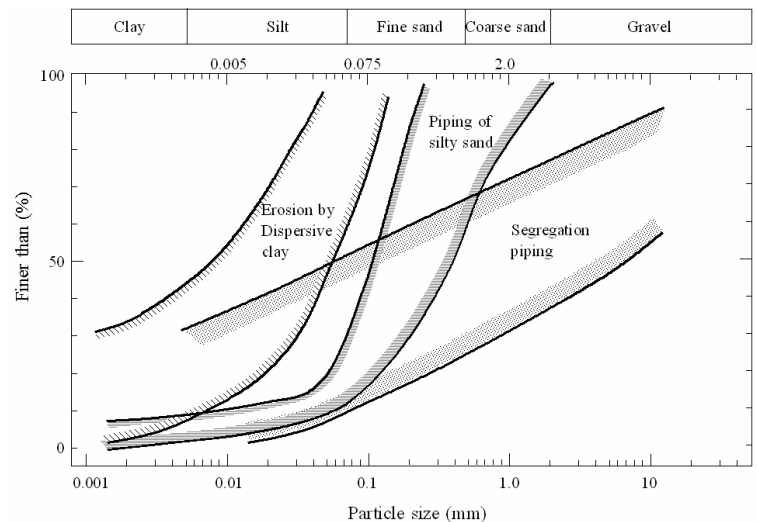
With respect to the piping or erosion, there would be three types of problems to be distinguished depending upon the range of grain size of soil materials in question. These are shown in a graphical form in Figure 13. The segregation piping has been the target of extensive studies in the past in association with the filter criteria for the design of rock fill dams. There are many studies reported in this context such as those by Terzaghi (1939), Kenny-Lau (1985, 1980), Skempton-Brogan (1994) and Sherad (1979).

The outcome of the grain-size analyses for the silty sand at Kaohsiung has shown that the soil there belongs neither to the broadly graded gravelly sands for the segregation piping nor to the dispersive clay related to the erosion or gully formation. In fact, the grain size in Kaohsiung soil lies midway in the range of silt and sand, as shown in Figure 13, which is coarser than the dispersive clay and finer than the soils related with segregation piping.

Figure 13. Three groups of soils in terms of grain size range associated with erosion and seepage instability
